Underground Water Distribution System Fort Belvoir, Virginia

Leak Detection Survey

CONTRACT #DACA01-94-D-0034
SYSTEMS CORP PROJECT #94013.09

August 1, 1995

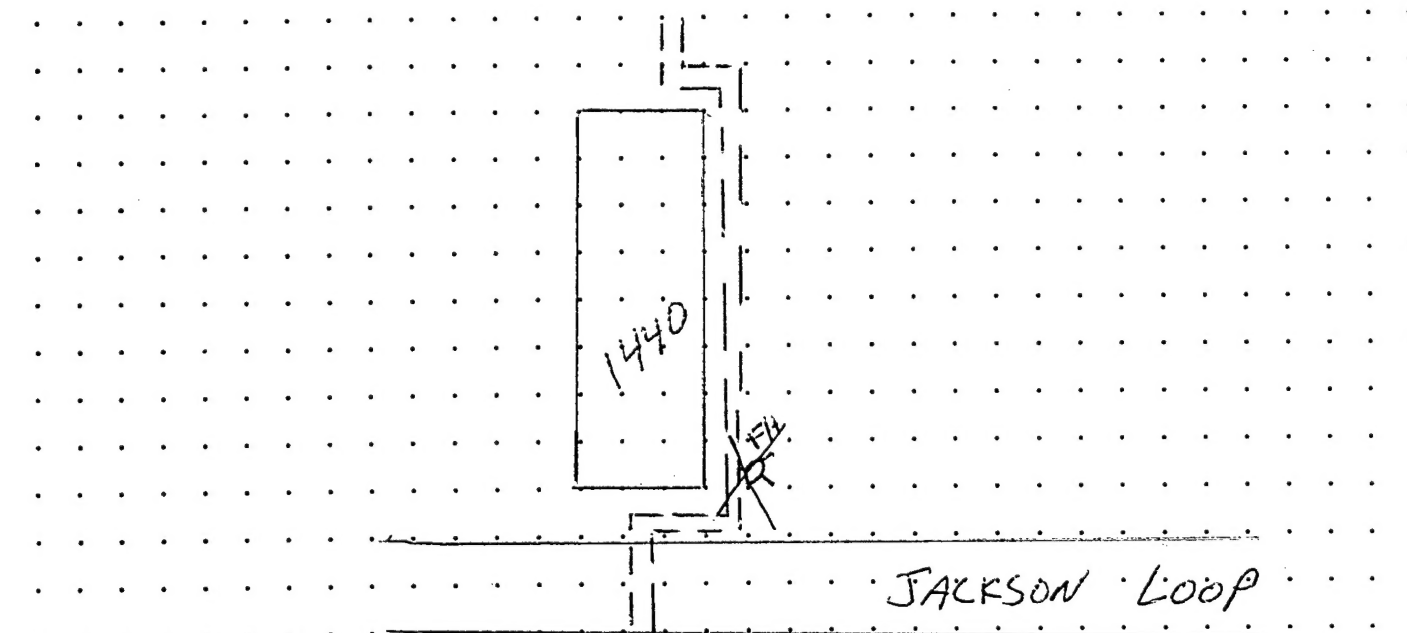
FINE hydrant in front of south side of
#1440 off Jackson Loop leaking

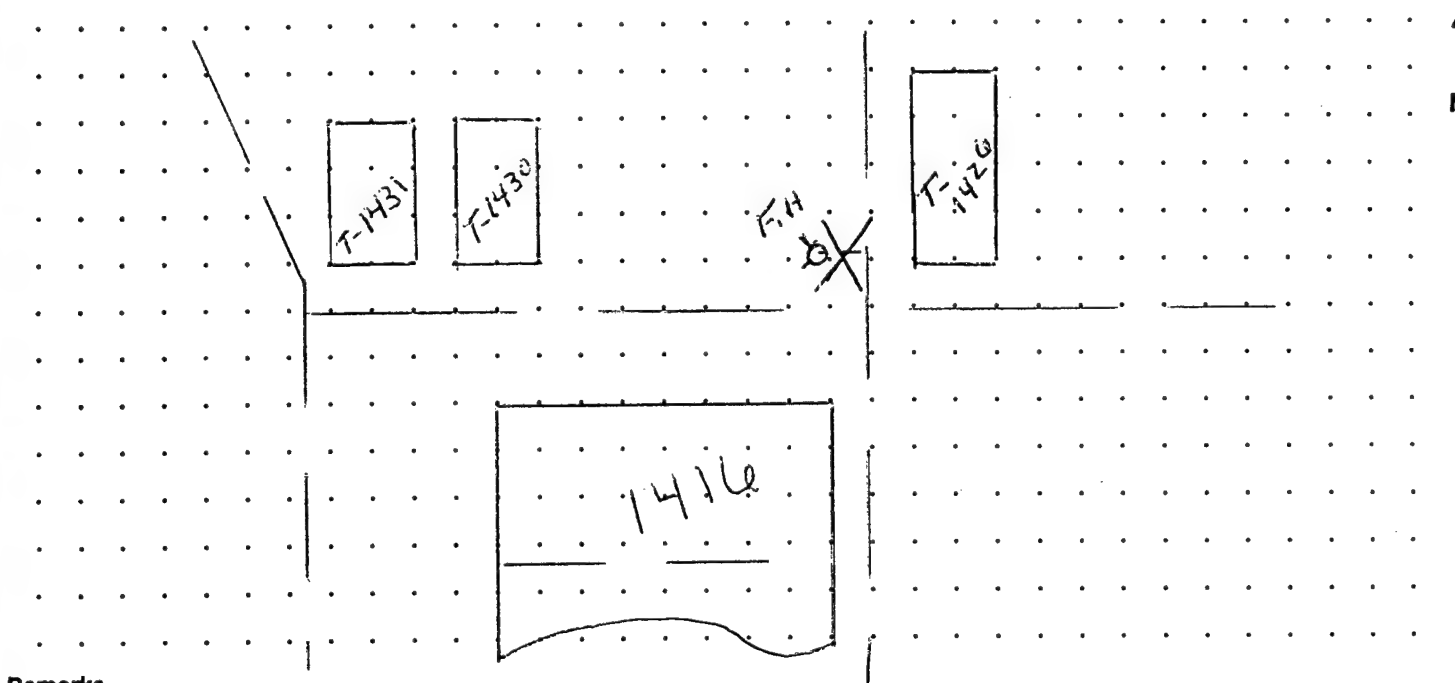
Page No. 2
Date 6-21-95
Ownership Public Private Easement
Leak Indication Classification
I(C) II(B) III(A)
(Circle One)

Fire hydrant at west side of Building T-1426
Leaking

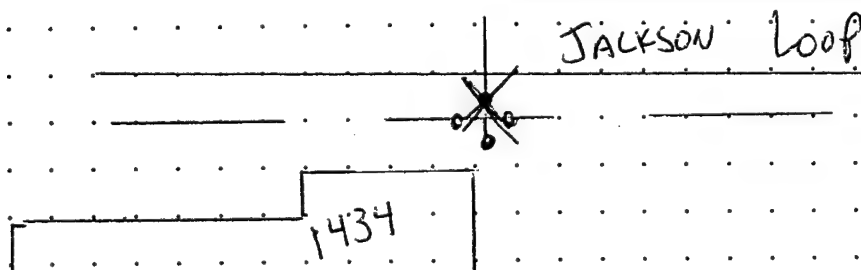
Page No. 3
Date 6-21-95
Ownership Public Private Easement
Leak Indication Classification
1 2 3
(Circle One)

VALVE CONTROLLING FLOW NORTH ON 8" LINE
RUNNING ALONG EAST SIDE OF BUILDING 1420 LEAKING. VALVE
IS OFF SOUTH SIDE OF JACKSON LOOP AT NORTHEAST CORNER
of BUILDING #1434

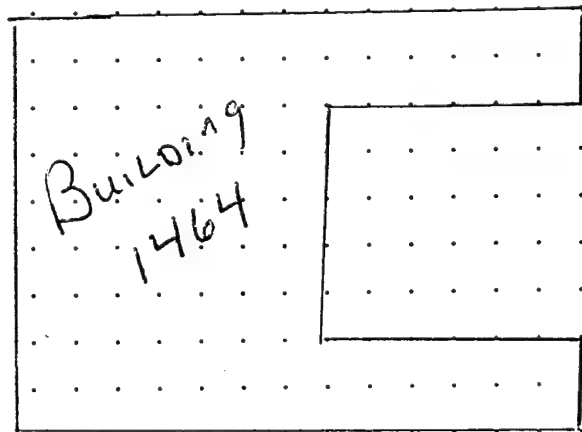
Page No. 4
Date 4-22-95
Ownership Public Private Easement
Leak Indication Classification
1 2 3
(Circle One)

FINE hydrant on EAST SIDE of Building #1464
Along HALL Road leaking

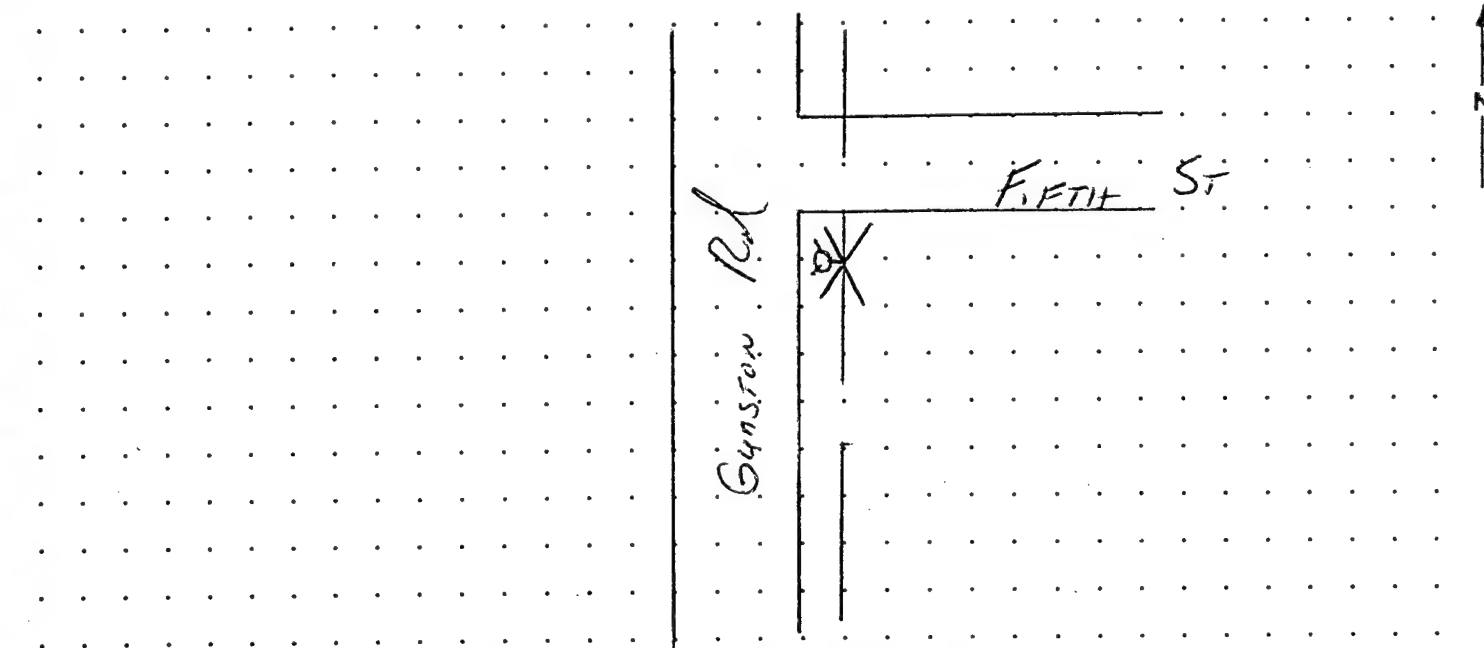
Page No. 5
Date 6-22-95
Ownership Public Private Easement
Leak Indication Classification
1 2 3
(Circle One)

Fire hydrant at intersection of Gunston Rd
& Fifth St leaking

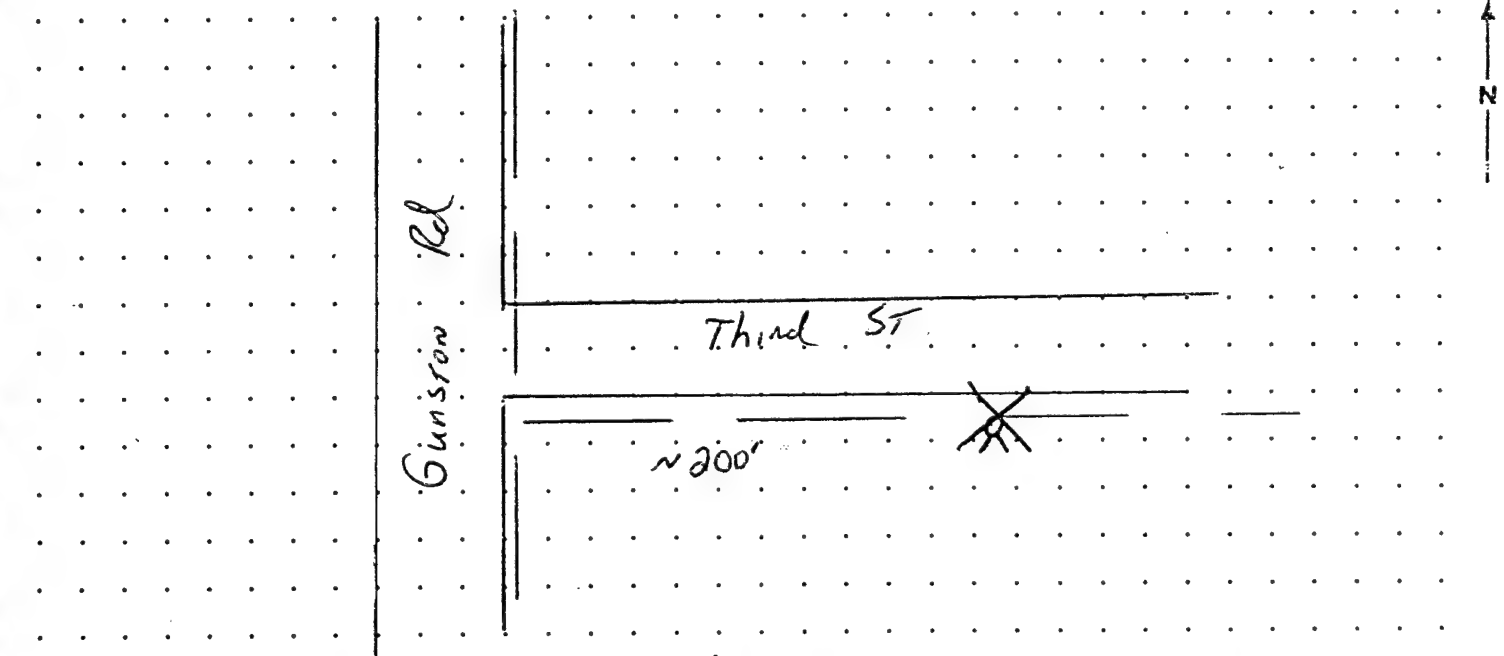
Page No. 6
Date 6-22-95
Ownership Public Private Easement
Leak Indication Classification
1 2 3
(Circle One)

Remarks Fire hydrant on Third St approx 200 FEET
EAST of INT of Third St + Gunston Rd LEAKING

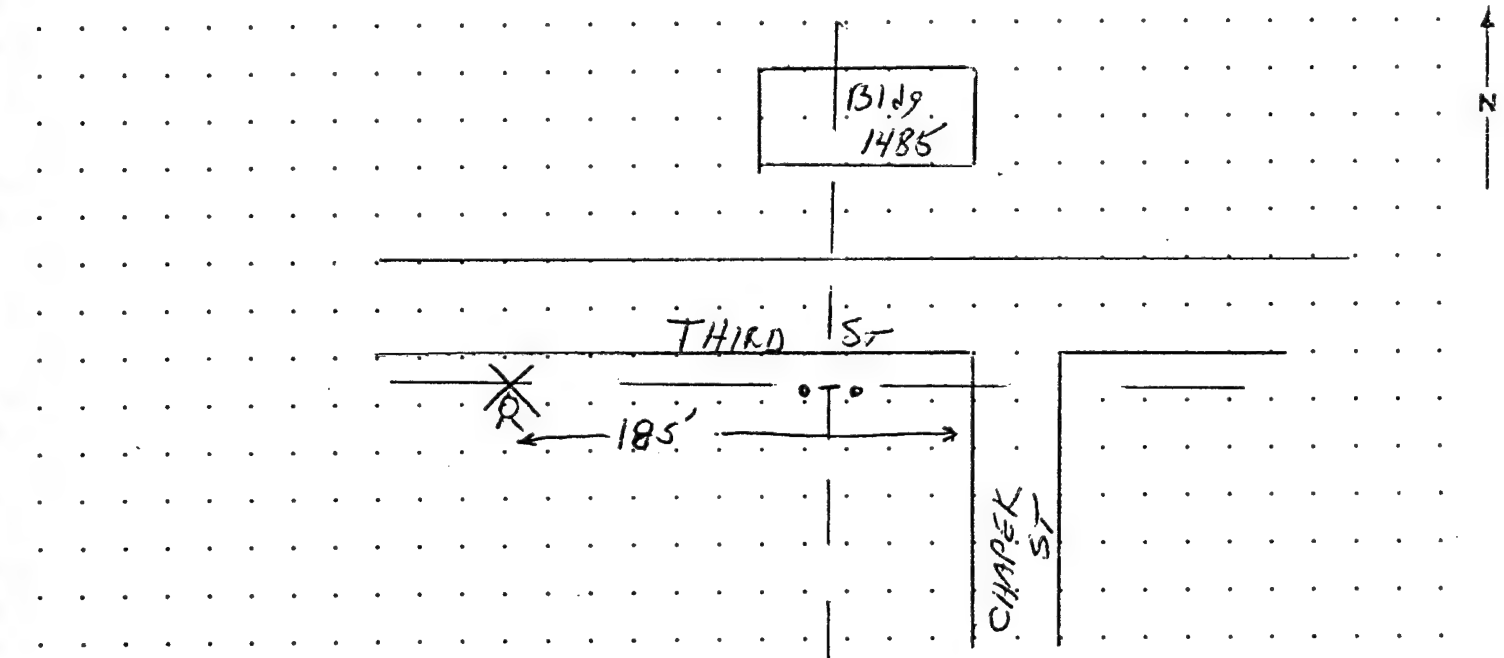
Page No. 7
Date 6-22-95
Ownership Public Private Easement
Leak Indication Classification
1 2 3
(Circle One)

Remarks Fire hydrant on Third St approx 185' west
of int of THIRD ST & CHAPEK ST LEAKING

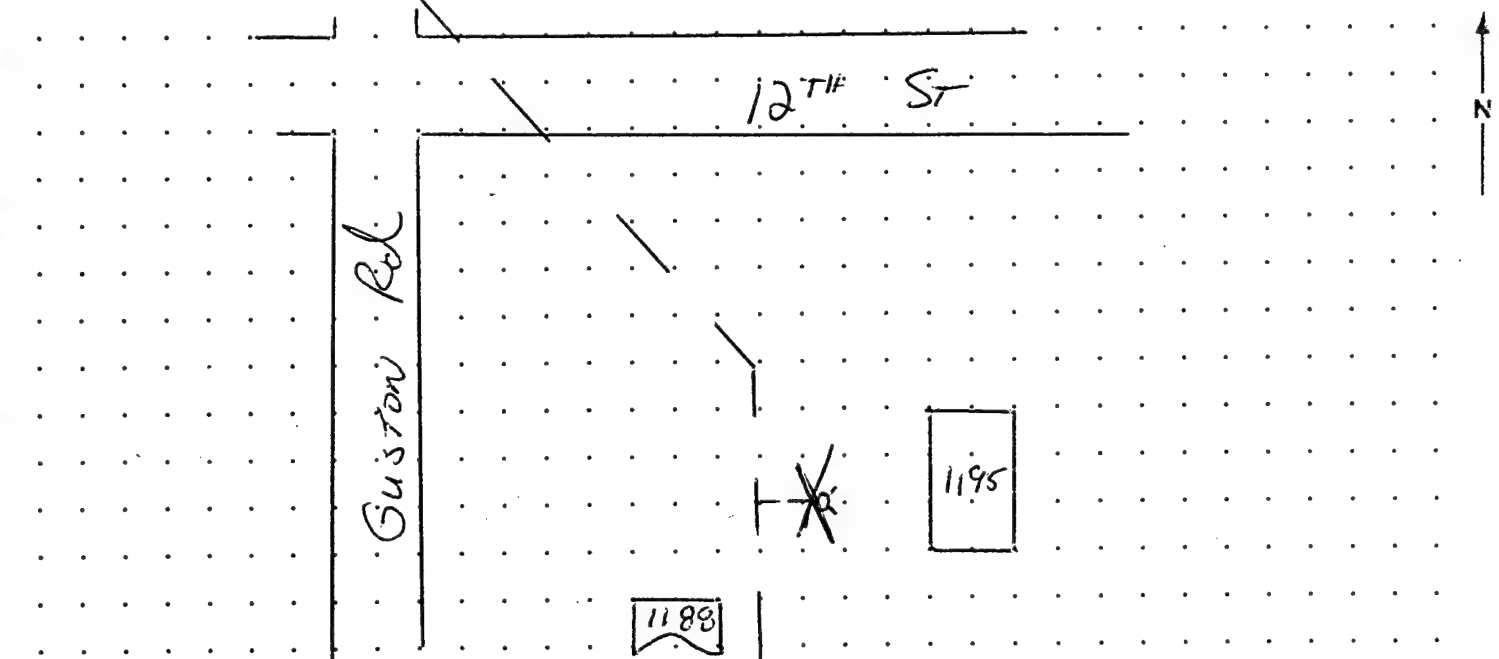
Page No. 8
Date 6-23-95
Ownership Public Private Easement
Leak Indication Classification
1 2 3
(Circle One)

Fire hydrant in grass in front of
Building #1195 leaking

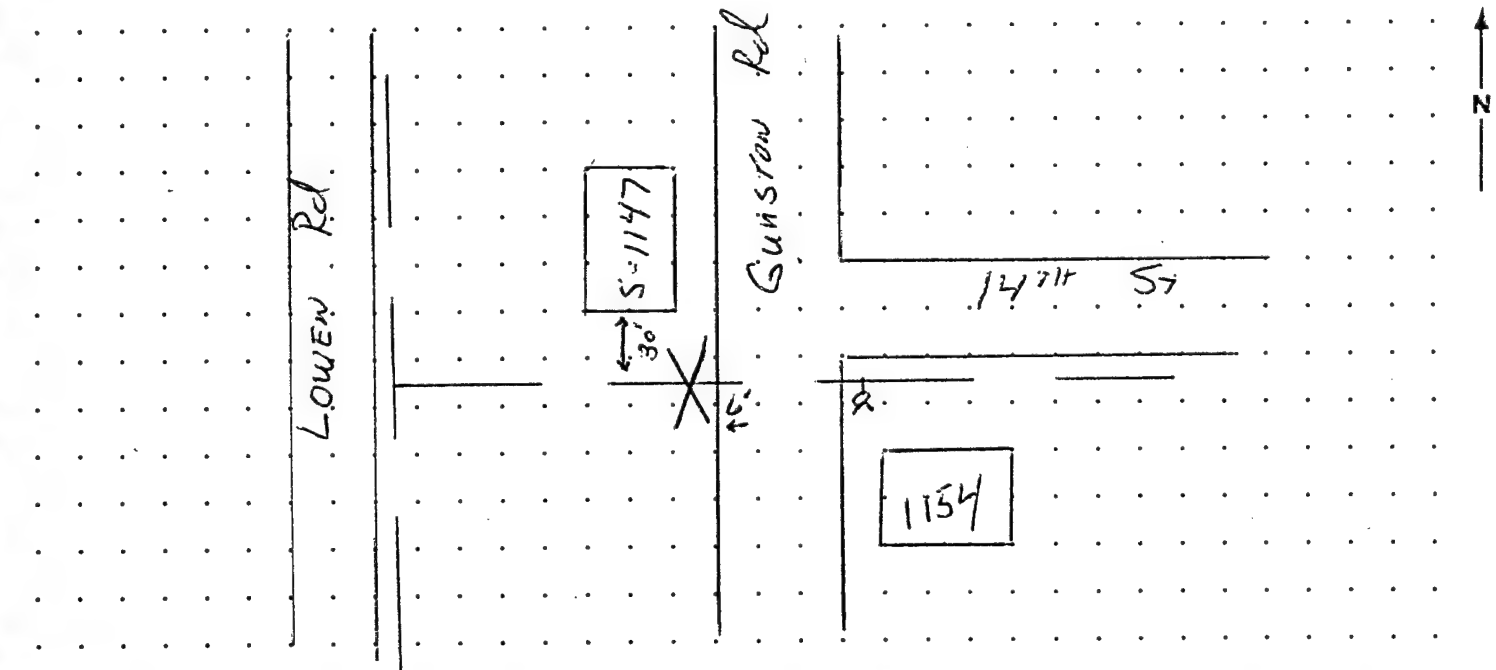
Page No. 9
Date 6-26-85
Ownership Public Private Easement
Leak Indication Classification 2
1 (Circle One) 3

Remarks LEAK on 8" main off 12" main. LEAK is
Behind CURBLINE south of Building # S-1147. LEAK
is approx 30" south of south Building Wall of # S-1147
and approx 6" west of west curb line of Gunston Rd
across Road from int. of Gunston Rd & 14th St

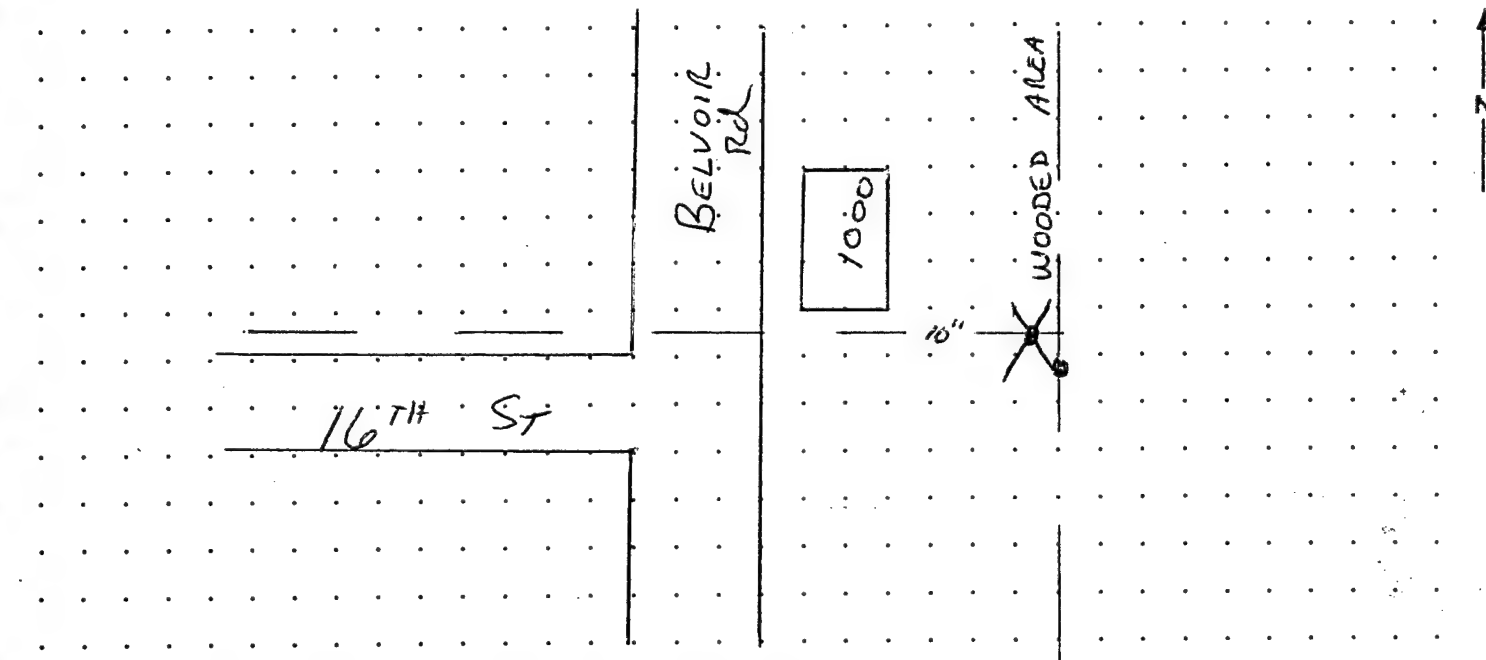
Page No. 10
Date 6-26-95
Ownership Public Private Easement
Leak Indication Classification
1 2 3
(Circle One)

LEAK APPEARS to be on MAIN, AT OR NEAR
VALVE (possible flange) on ~~the~~ line running WEST along
side of Building #1000. LEAK & VALVES ARE IN WOODED AREA
Behind Building #1000.

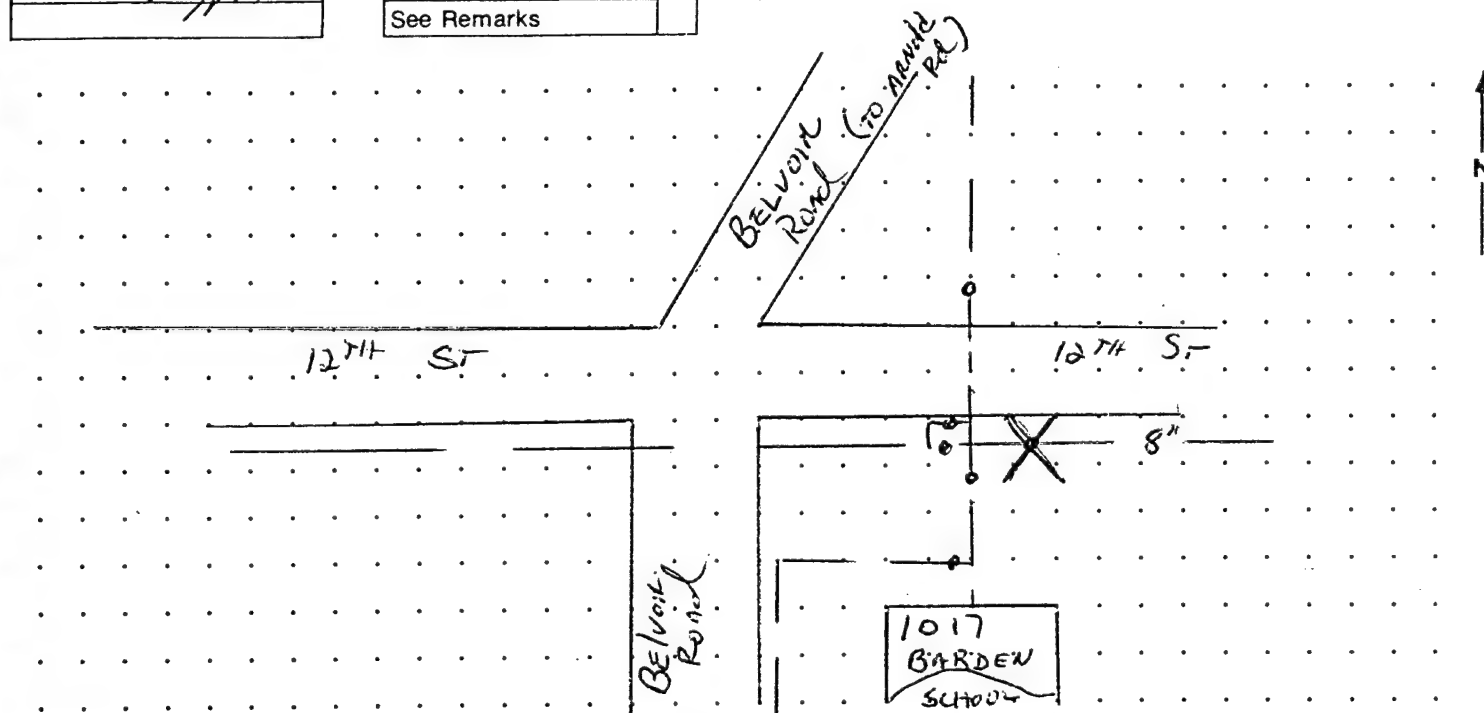
Page No. 11
Date 6-26-95
Ownership Public Private Easement
Leak Indication Classification
1 2 3
(Circle One)

8" valve controlling flow EAST on 12th ST
from valve group along 12th ST in front of #1017
(BARDEN School) leaking - WATER SURFACING

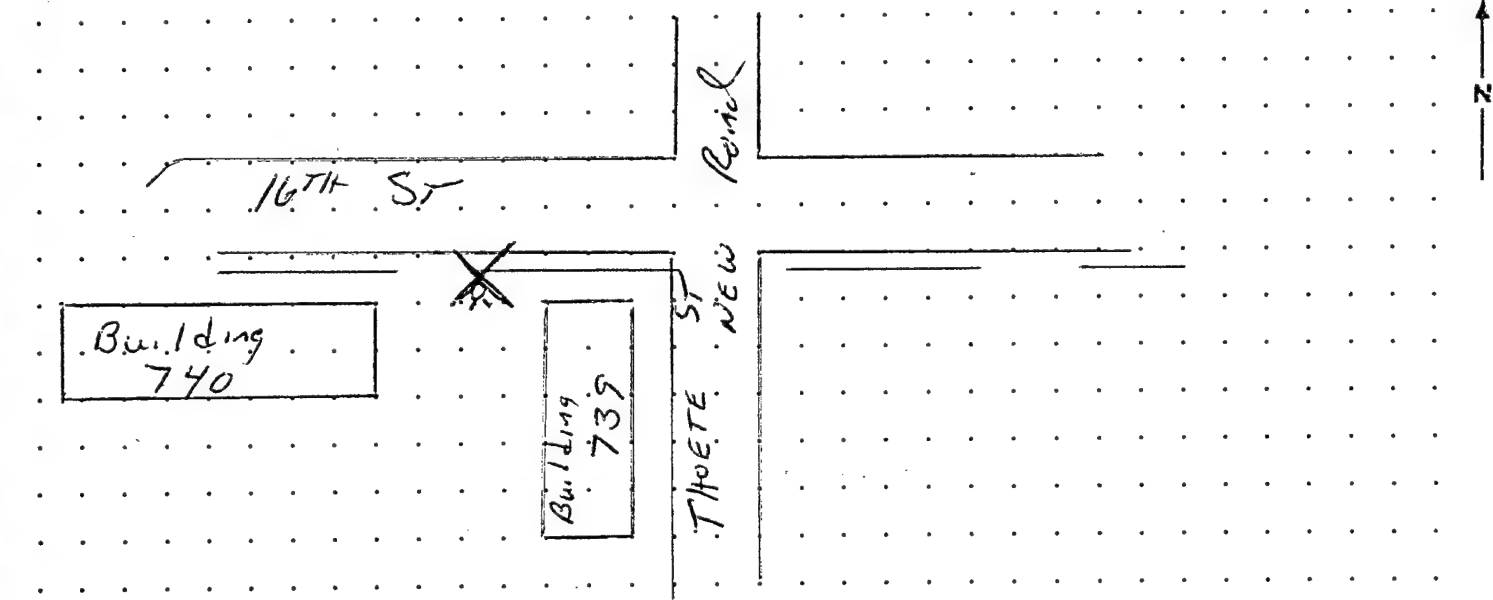
LEAK appears to be at FIRE hydrant, possibly had
INTERNAL AT FIRE hyd on 16TH ST Between Buildings # 739
& 740

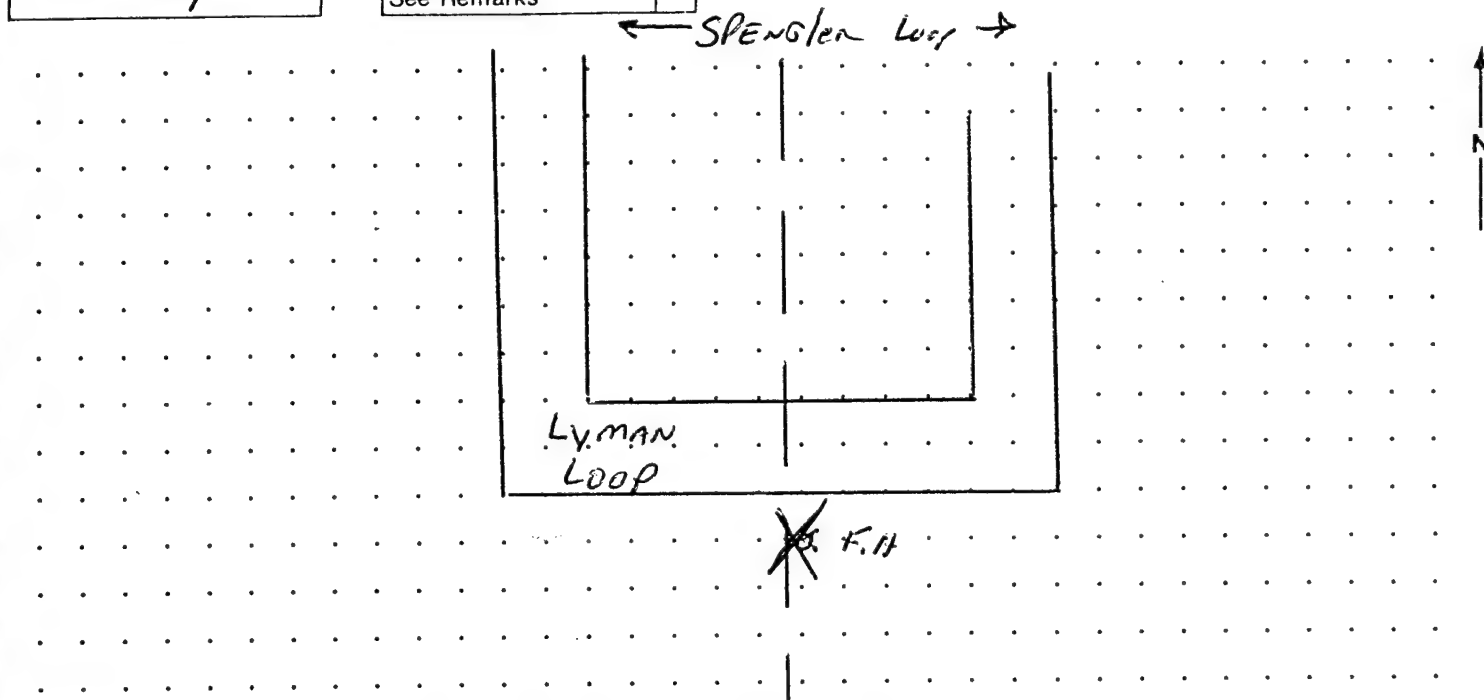
Fire hydrant Body at FIRE hydrant on
Back side of Lyman Loop cracked - Fire hydrant
has 1 1/2" crack in Body

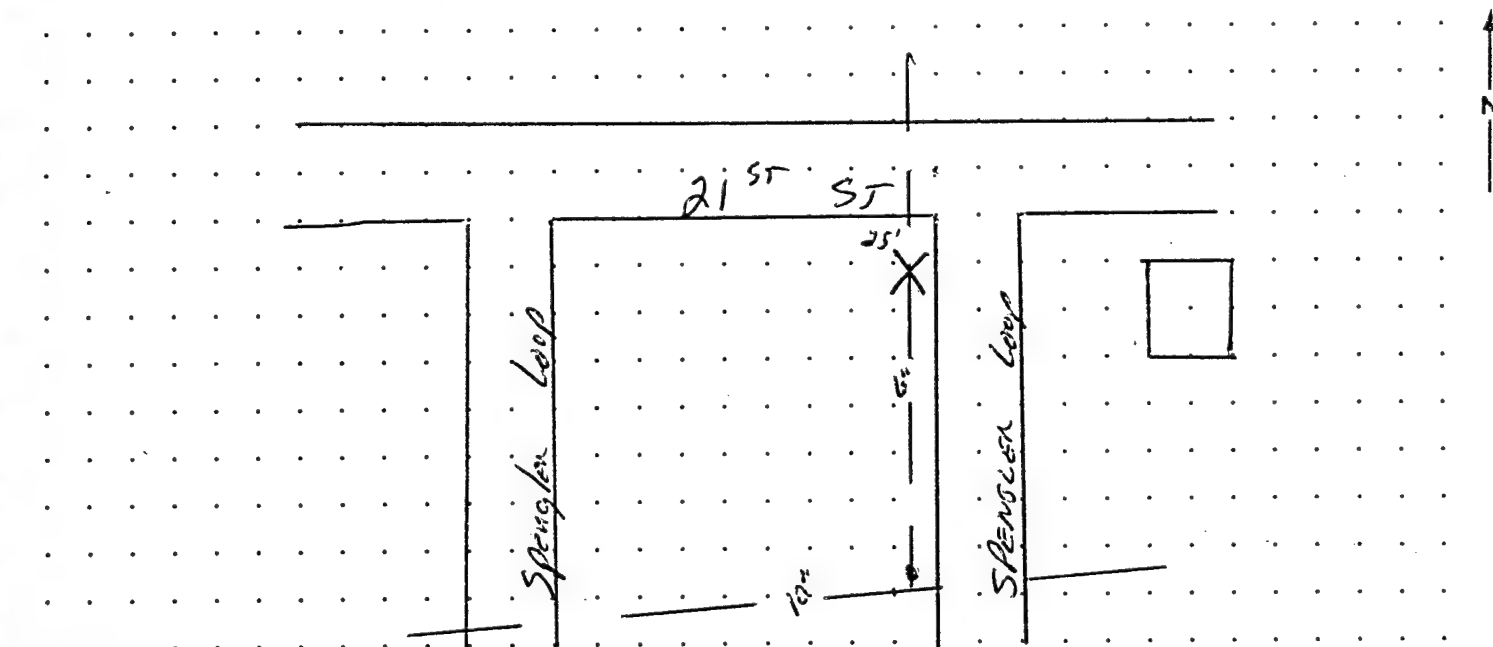
<u>5 gpm</u>

LEAK on 6" main running on west side of
Spengler loop at 21st ST - LEAK SURFACING - LEAK
is ~ 25' off 21st ST into soil

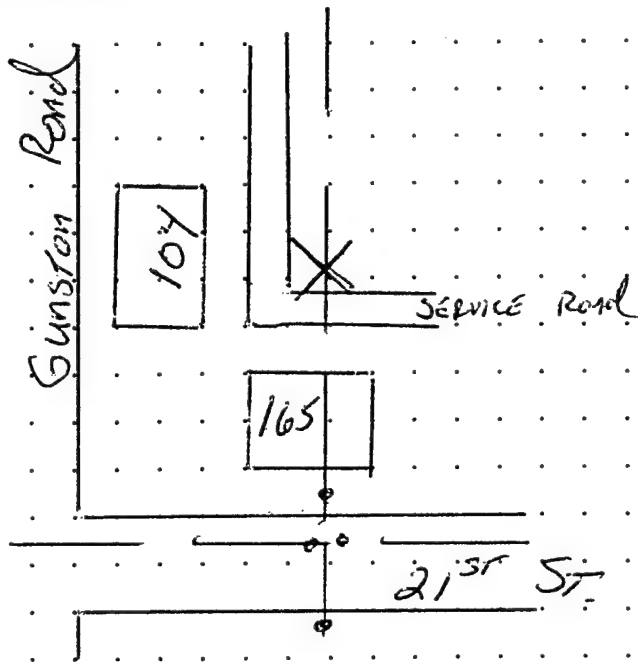
Page No. 20
Date 7-11-95
Ownership Public Private Easement
Leak Indication Classification
1 2 3
(Circle One)

<u>20 gpm</u>

LEAK APPEARS TO BE ON MAIN ALONG NORTH
SIDE OF SERVICE ROAD BEHIND #165 21ST ST

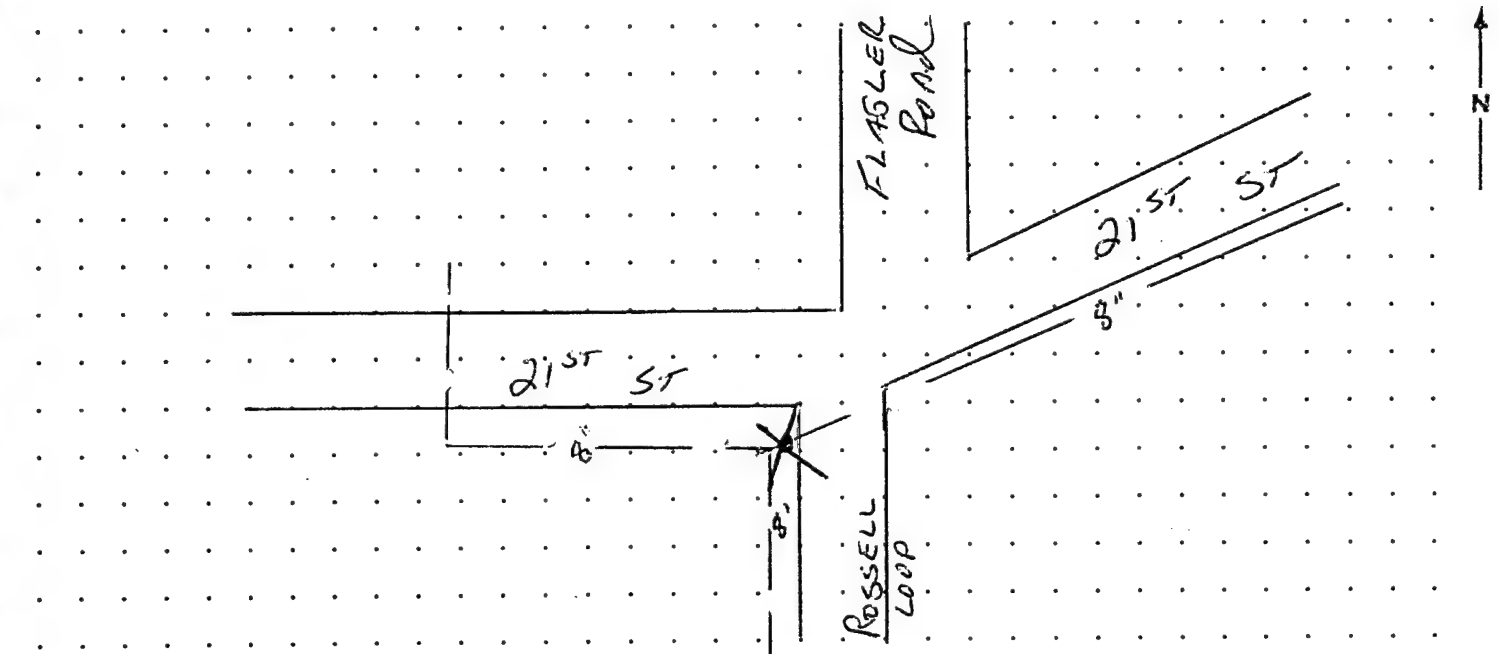
Page No. 21
Date 7-11-95
Ownership Public Private Easement
Leak Indication Classification
1 2 3
(Circle One)

Remarks 8" MAIN VALVE AT SE. CORNER of int of
Rossell Loop & 21ST ST. WATER SURFACING

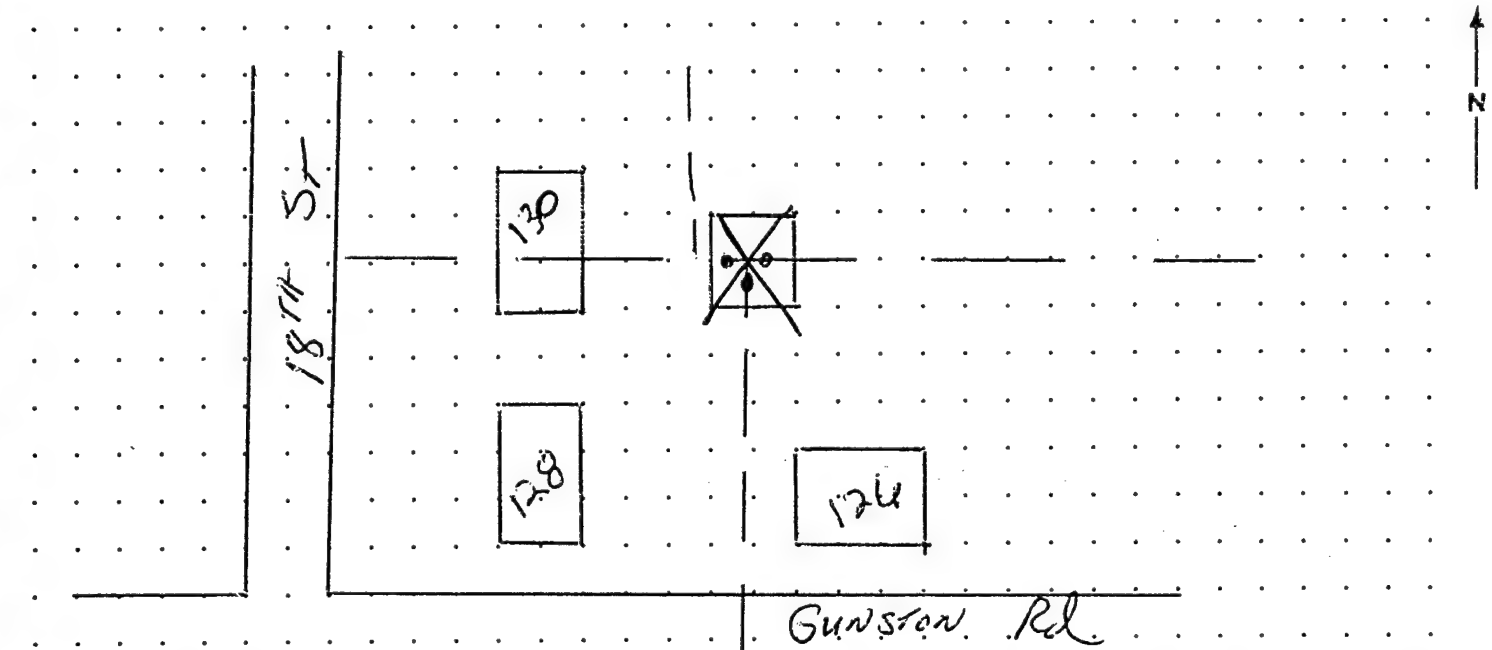
Page No. 22
Date 7-11-95
Ownership Public Private Easement
Leak Indication Classification
1 2 3
(Circle One)

Remarks LEAK appears to be on valve in value pit at
REAR OF #130 18TH ST. Pit is full of water
so exactly which valve is leaking cannot be determined

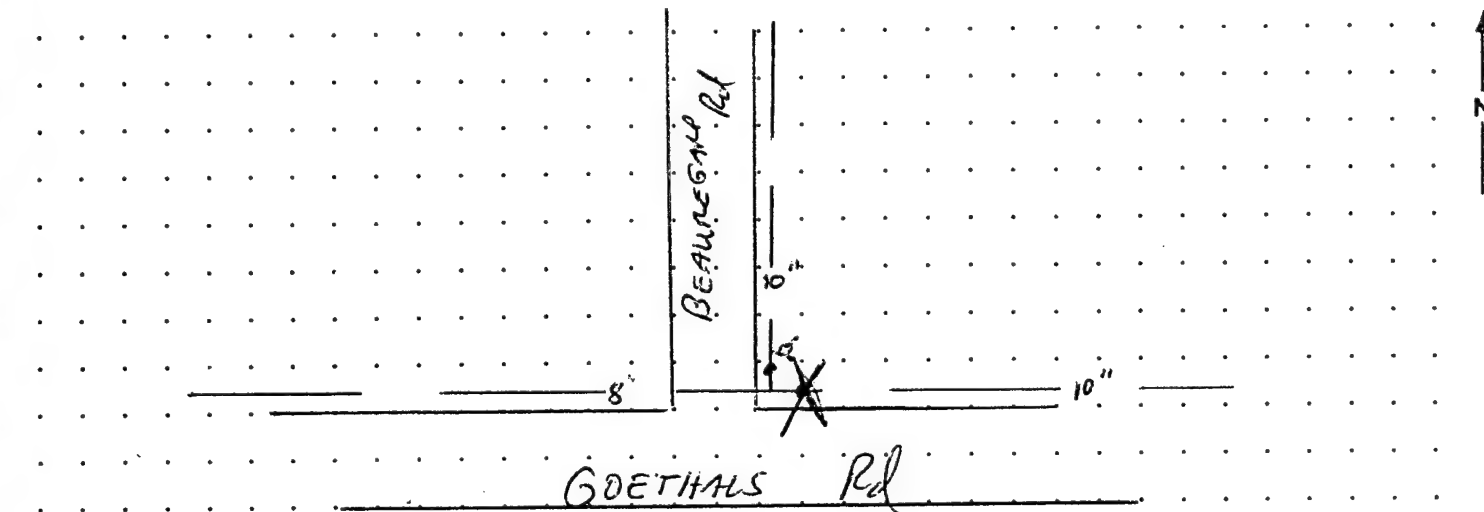
10" MAIN VALVE controlling water flow EAST
ON GOETHALS Road FROM INT WITH BEAUREGARD Rd
leaking

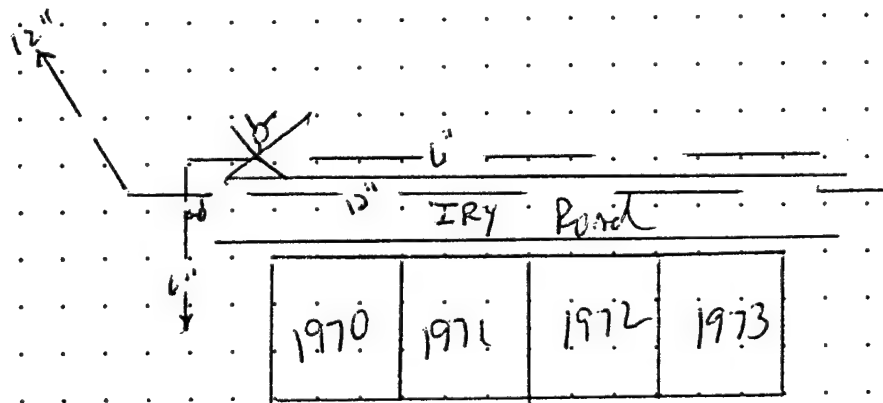
Page No. 24
Date 7-13-95
Ownership Public Private Easement
Leak Indication Classification
1 2 3
(Circle One)

Fire hydrant AT REAR of #1970 IRY Road
LEAKING
A POSSIBLE SECOND LEAK HERE - maybe 12" x 6"
REAR TIE IN. TOO MUCH MUD, WATER & CAT TAILS
TO LOCATE EXACT SOURCE of surfacing
water

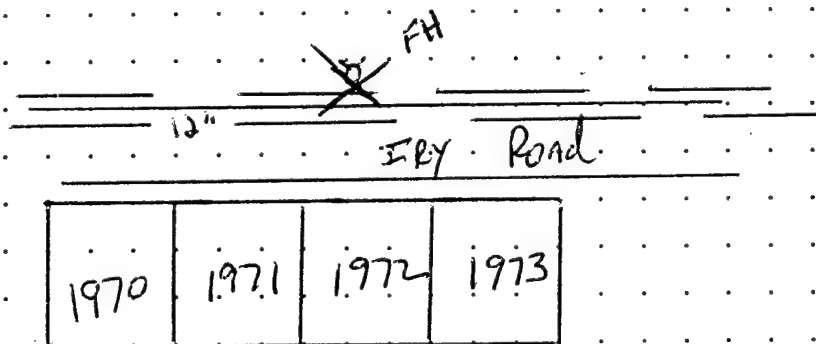
Page No. 25
Date 7-13-87
Ownership Public Private Easement
Leak Indication Classification
1 2 3
(Circle One)

Fire hydrant across ERY Road from Building #1972
leaking

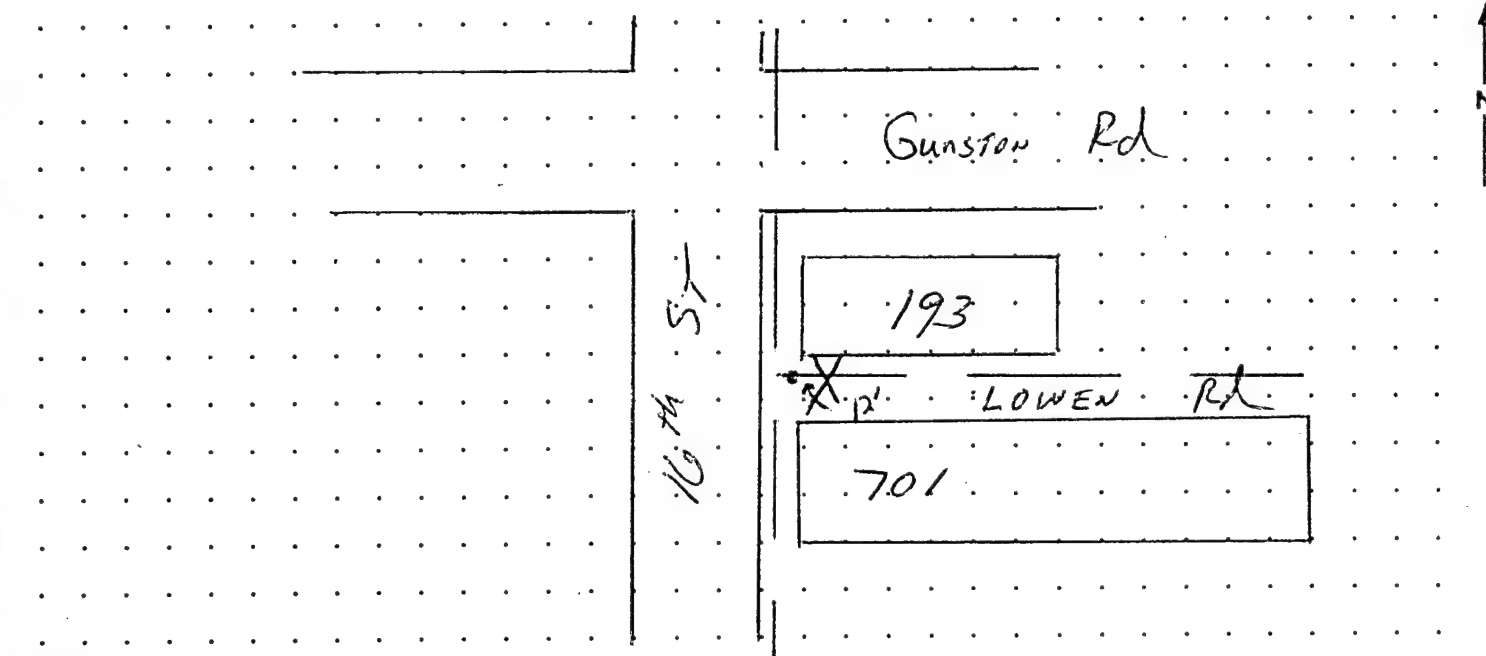
<u>10 gpm</u>

LEAK APPEARS to be on 6" MAIN RUNNING
EAST FROM 16th St BETWEEN BUILDINGS # 193 & 701.
LEAK IS APPROX 12' EAST OF 6" MAIN VALVE AT INT
OF 16th ST & ACCESS ROAD BETWEEN BUILDINGS (LOWEN Rd)
193 & 701

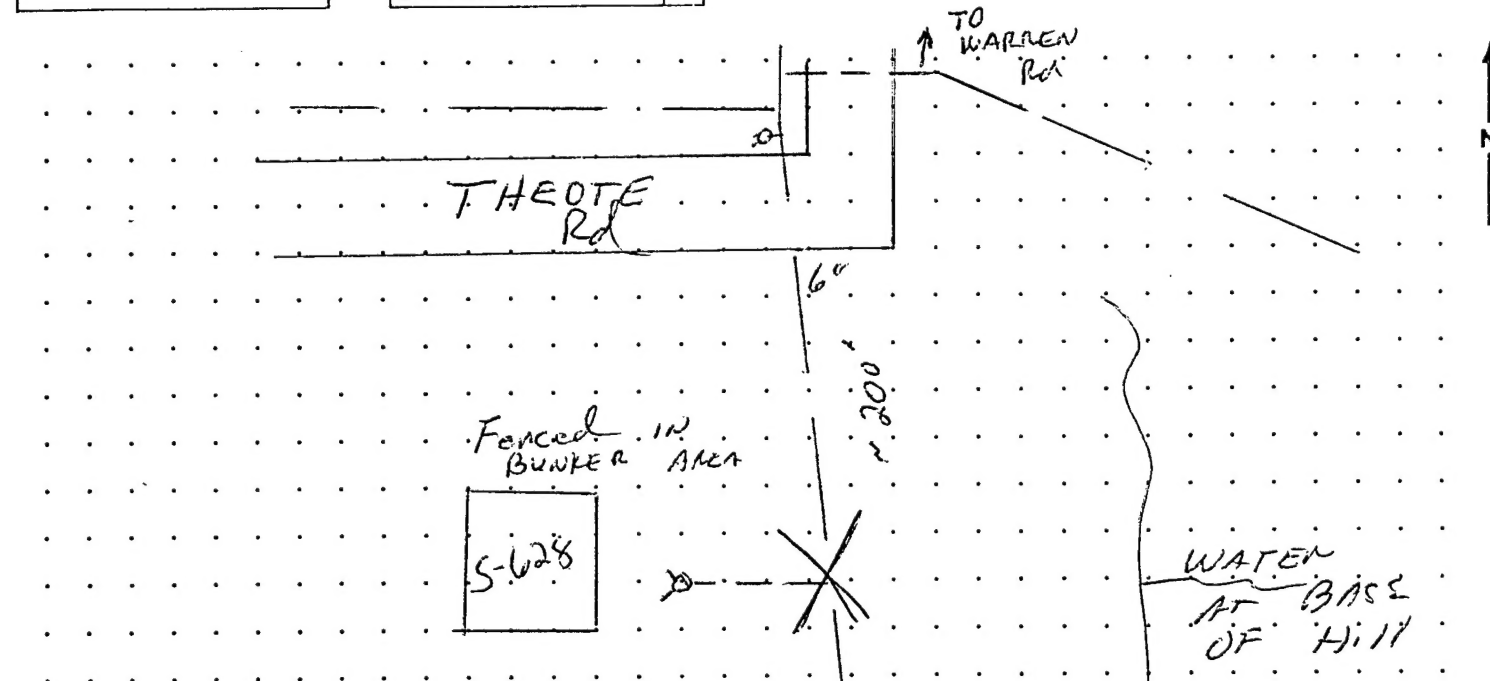
Page No. 28
Date 7-14-95
Ownership Public Private Easement
Leak Indication Classification
1 2 3
(Circle One)

LEAK APPEARS TO BE ON 6" MAIN IN
RIGHT OF WAY OFF OF THEOTE ROAD. LEAK IS IN
AREA OF FIRE HYDRANT "T" NEAR BUILDING S-628

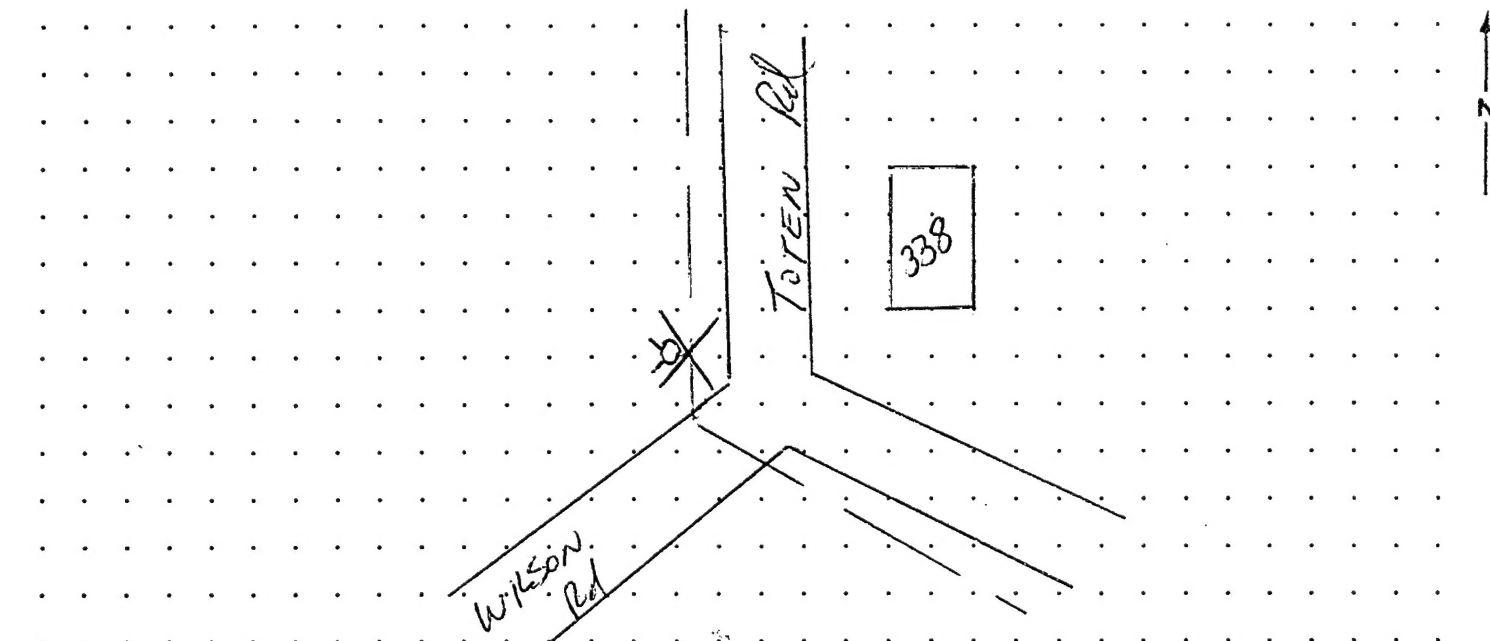
Page No. 29
Date 7-14-95
Ownership Public Private Easement
Leak Indication Classification
1 2 3
(Circle One)

Remarks Fire Hydrant across TOTTEN Road from BUILDING
#338 LEAKING

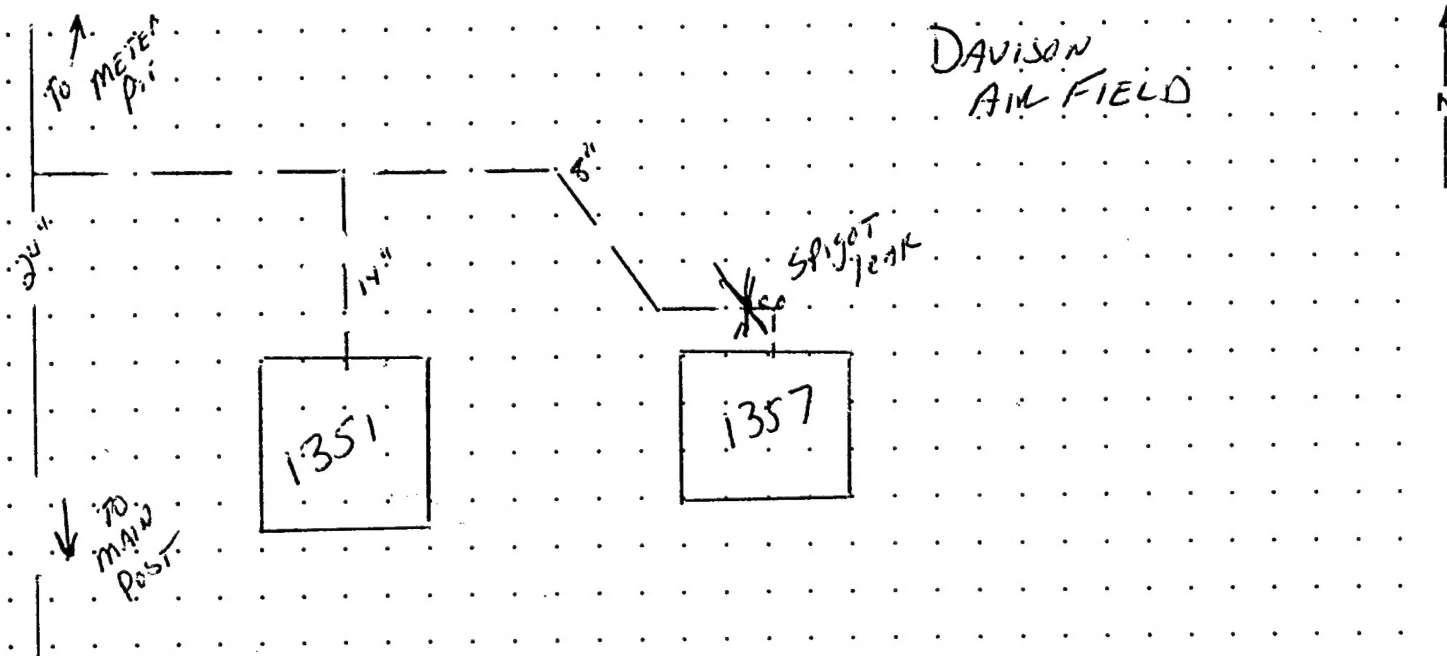
Page No. 30
Date 7-17-95
Ownership Public Private Easement
Leak Indication Classification
1 2 3
(Circle One)

<u>1 gpm</u>

OUTSIDE YARD SPRIGT LEAKING AT BASE
WATER SURFACING

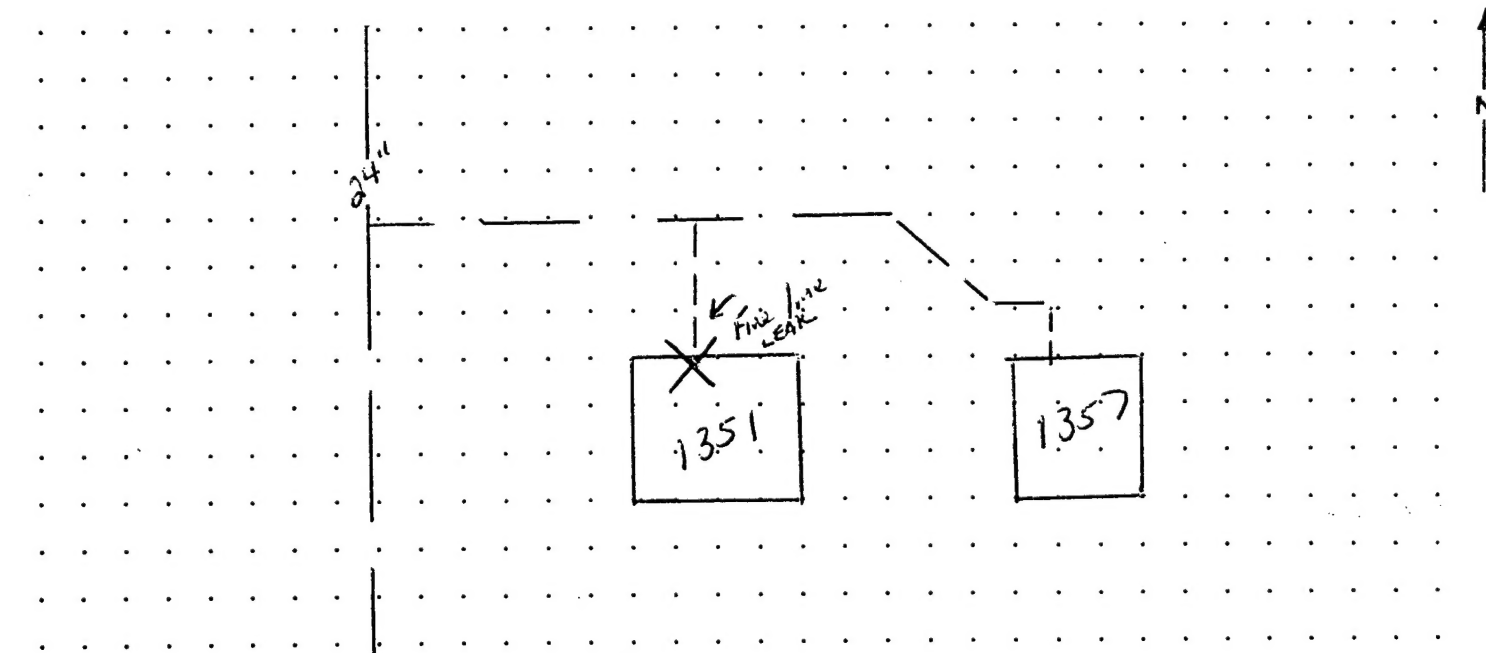
Page No. 31
Date 7-17-95
Ownership Public Private Easement
Leak Indication Classification
1 2 3
(Circle One)

<u>1 gpm</u>

Check valve on sprinkler line in Building
1351 leaking through drain line. Water coming out
drain line outside building
